## MEMORANDUM

SUBJECT: Reclamation evaluation for OSM, Gallup Field, Biava Mine No. 3

\* Biava No. 3 mine 2400' NL, 400' EL, 10-15-18 Loc. 10

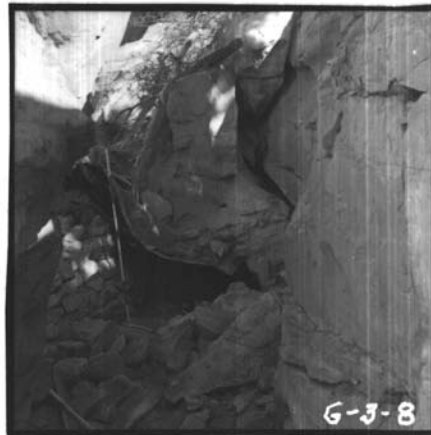
The Biava No. 3 mine, location 10, was opened by two drifts on the coal bed, reportedly to recover pillars left in the Sunshine mine. The aircourse is to the right or to the east and the main entry is on the left. It was immediately noted by the examiners that the mine is on fire. Big sandstone boulders have sloughed down and made the area about the portal quite dangerous for people to crawl about. Both drifts are closed to access. On the rim rock above the drifts the ground is crossed with cracks, and coal smoke was noted coming from several places. The fire could be controlled

G-3-8 View looking N.  $42^{\circ}$  W. at the collapsed aircourse showing the effect of the fire on the rim sandstone.

by cleaning up the face of the rim rock along the fire areas and compacting material in front and on top of the rim rock to exclude air from feeding the fire. The fire is feeding on pillars. An evaluation of the feasibility of its control should be taken. The land is poor and not used. The fire over the years could spread over quite a distance as that particular rim rock extends back quite a distance and it will continue to break as the fire advances. The area affected by the fire at present is triangular in shape. The bearing of one side of the triangle is S.  $24^{\circ}$  E., 168'; another side of the triangle bears S.  $47^{\circ}$  W., 204'; and the rim over the portal forms the third side of the triangle. At present the area seems relatively small. I would say the fire should be controlled.

\* It is recommended that the fire be controlled and the dump area be policed of its junk and debris.

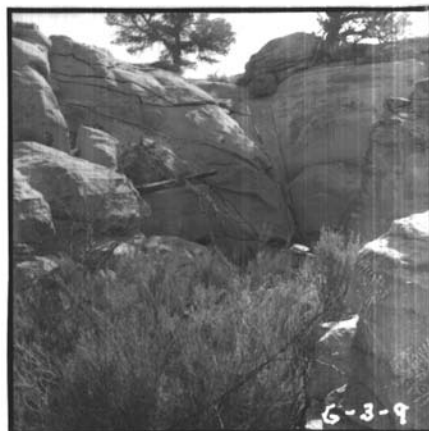
G-3-9 Another view of the aircourse, looking east. Steam can be seen at the end of the range pole. The rock temperature at the vent is about  $90^{\circ}$  to  $100^{\circ}$  F.

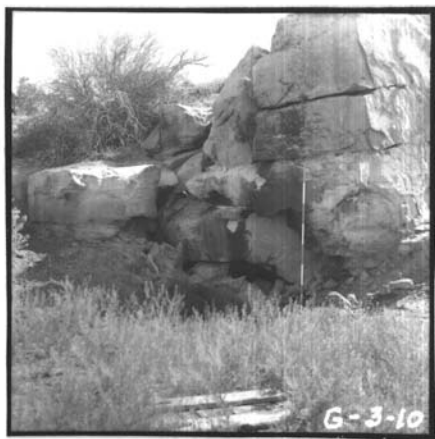
G-3-10 The photo shows the main adit that bears N.  $15^{\circ}$  E.

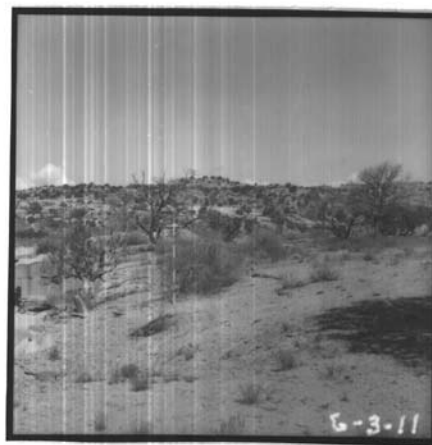
G-3-11 This is a view looking N.,  $60^{\circ}$  W. on the top of the rim. The smoke from the mine fire is evident, and the heat has killed juniper trees and other vegetation over the area.

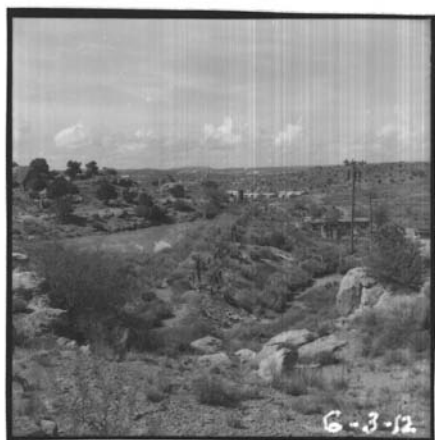
G-3-12 This is a view looking S.  $25^{\circ}$  W. from on top of the rim above the main portal, showing the tram road to the dump and coal bins that are now in ruin. Recent rains have kept the pond that was formed by the tram about full. Mr. Biava's home which he rents is to the west of the tram road. Note the tram road to the dump is at a right angle to this road; this leads to the portal of a slope at the base of the rim slope. This could have been Biava's No. 2 mine.

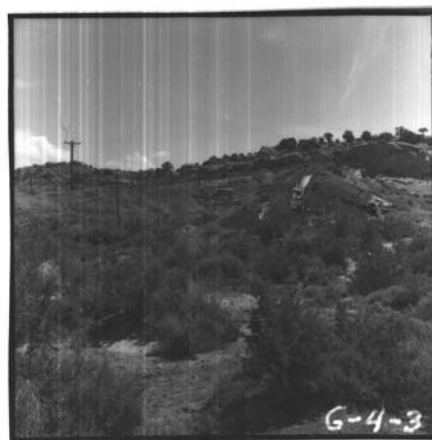
G-4-3 View of the Biava dump looking to the north. Note the tram to the left in the photo which goes to location 33. The area of the dump could stand some housecleaning.
