MEMORANDUM

SUBJECT: Reclamation evaluation for OSM, Gallup Field, Black Diamond Mine

* Black Diamond Mine 4000' NL, 4700' EL, 10-15-18 Loc. 8

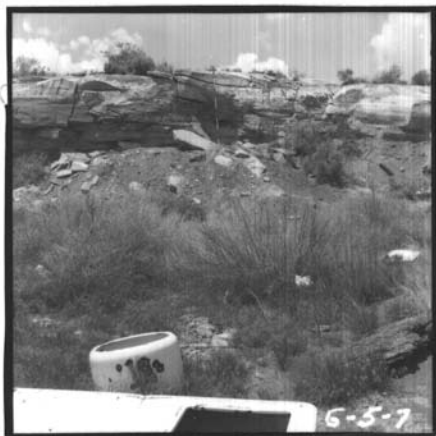
The examiners found two adits and a shaft which were doubtless the mine openings. The main alit was well sealed but an opening about 50' northeast was partly open and it had been used by someone as a shelter. The shaft, 8' x 6', near the southwest corner of the horse corral, was open 30' to 40'.

G-5-7 View of the main adit of the Black Diamond Mine, which is sealed. The range pole is at the location of the opening. The coal and refuse were trammed south to the loading and dumps on the Diamond Valley floor.

It is recommended to backfill the one adit and the old shaft SW of the horse corrals. A better search should be made to determine holes created by subsidence exist, between the openings and the base of the rim.

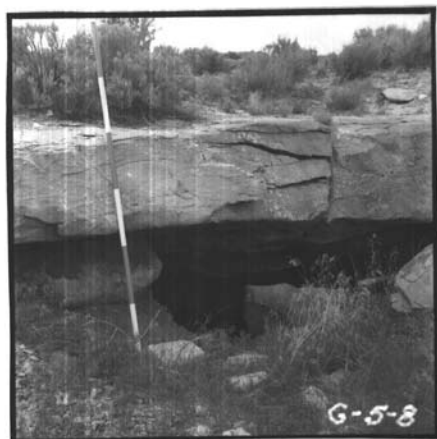
G-5-8 A view of the opening about 50' NE of the main adit which is open for 10' one way and 15' north-south. The Indians or somebody have used this small opening for a shelter as old rugs cover the floor.

The adit and the shaft should be backfilled. The openings are about 1000' to 1400' from the school and residential area. The area apparently is not used at the present time.

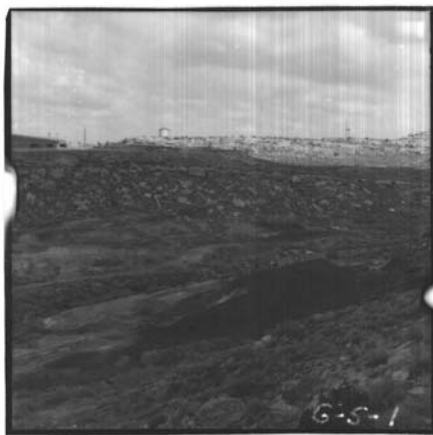
G-5-1 View looking N. 70° W. at Diamond Gulch. It shows the old mine dumps from the Black Diamond et al mines. The mine portals were all above this rim to the north. Note the water tower on the horizon, the new school on the left. This school is apparently not over any of the mines.
