MEMORANDUM

SUBJECT: Reclamation evaluation for OSM, Gallup Field, Catalpa Mine,
Bread Springs Quad.

* Catalpa Mine 1800' NL, 900' EL, 34-15-18, Locations BS-5, BS-3, and
BS-4

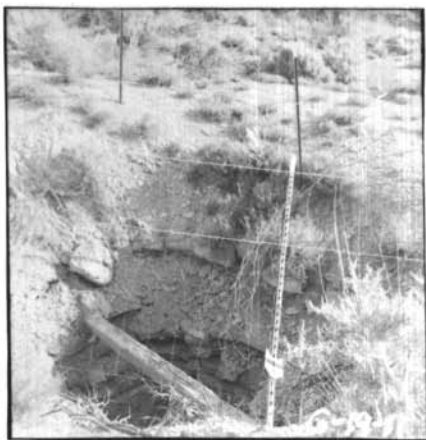
The examiners found two slopes and two shafts, as shown on the map. The main vertical shaft for ventilation, Location BS-3, is open for at least 40'. The ranch family who live in the immediate vicinity have put up a temporary fence around the opening. They would certainly like to have this shaft filled because they have expensive stock grazing over the area. The main slope, which bears S. 70° W., has an opening 1' or so in diameter, Location BS-5.

* G-19-11 This is a view of the shaft at Location BS-3. The opening was fenced by the land owner, but it is a temporary closing at best. The shaft is estimated to be at least 40' deep. The land owner expressed a desire to have the opening filled.

* The reclamation recommended is to backfill the shaft at BS-3 and the two slope openings. The shaft at ES-3 should be considered a priority.

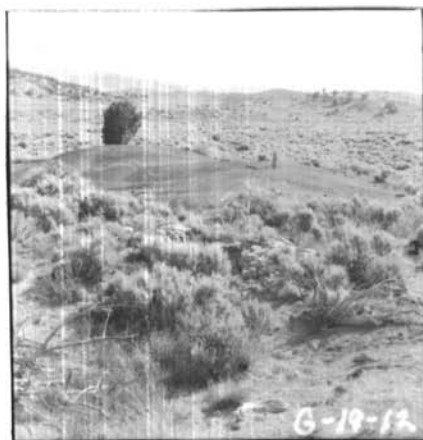
for 15' or more. A ventilation shaft 60' east of the second slope is sealed with the remains of a furnace, which was used to aid ventilation, over the opening. Considerable dump remains on the site, but the main dump has fired and now provides a good source of road ballast.

G-19-12 View of the dump and furnace at the eastern openings, Location BS-4. The rock work in the foreground is the furnace. The photo was taken looking N. 30° E.

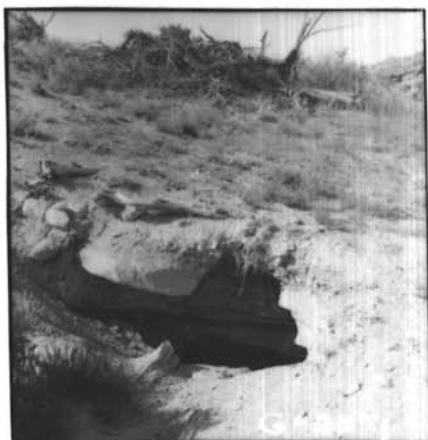
The second main slope to the east, which bears S. 25° W., is open

* G-20-1 This is a view of the eastern slope, which is open but well guarded by a sleeping rattlesnake. The slope bears N. 25° W. and is open for at least 15'. It should be filled. The snake was not disturbed and he will be there when the adit is backfilled.

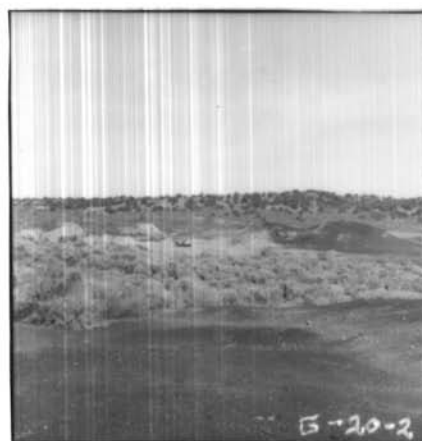
G-20-2 View of the main dump taken from the furnace shaft site, looking N. 65° W. The dump has provided considerable red dog for road ballast.

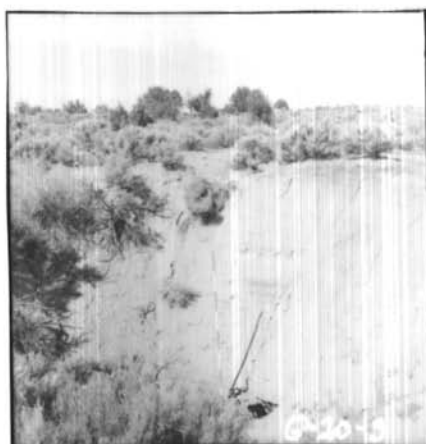
* G-20-3 View of the main slope. The slope bears S. 70° W. and is open with a hole a foot or so in diameter.
