## MEMORANDUM

SUBJECT: Reclamation evaluation for OSM, Gallup Field, Gallup West,  
Clarke Mine

Clarke Mine 1400' NL, 1600' EL, 14-15-19, Location 20

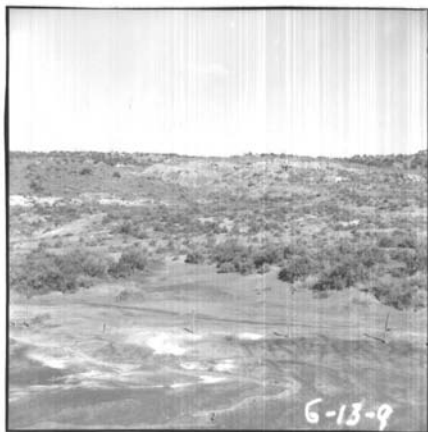
G-13-9 This is what I believe to be the main entry of the Clarke mine. It was taken looking west. Foundations are in the vicinity, probably those for the boiler plant. At the base of the white cliff is a mine tram road. The railroad grade is about 300' from the camera. The photo was taken from the burned screening pile.

No reclamation is needed. The subsidence area is in very rough area, and the holes are no worse than the deep narrow arroyos.

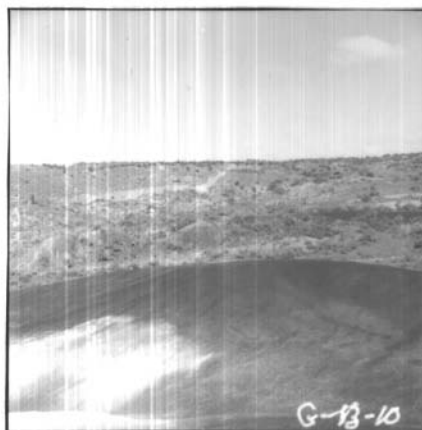
G-13-10 I moved down the refuse pile a short distance and took this photo. The white cliff is at the right, the tram road shows, and the portal of the main entry is just beyond the gap in the tram road. The dump at the right of the water is from recent dozing. The dump in the foreground is burnt screenings. The only evidence of the portal is a cap sticking out of a depression.

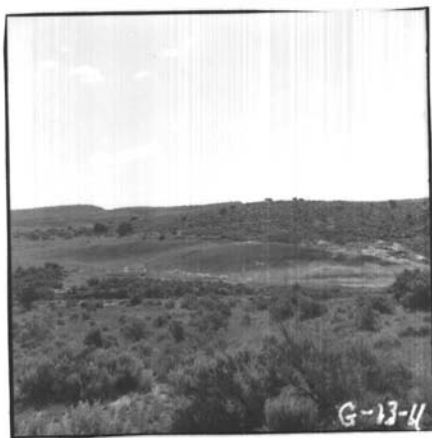
G-13-11 Looking east, to show the refuse dumps.
