## MEMORANDUM

SUBJECT: Reclamation evaluation for OSM, Gallup Field, Gallup West,  
Defiance No. 2 Mine, Defiance No. 3 Mine, and Defiance No. 6  
Mine, (Carbon City Mine)

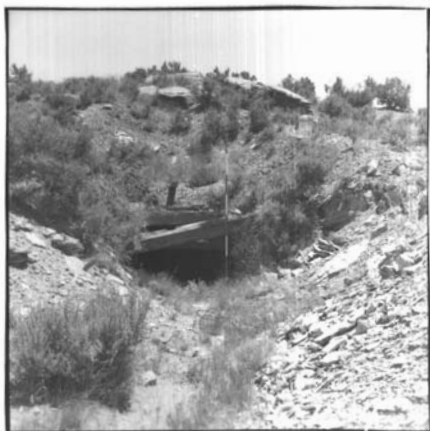
\* The mine was opened by two adits. The air course, which bears S. 40° E., is open for about 50', blocked only partly by a wooden door which is still hung on the portal timber. It should be sealed. The main adit, which is located about 300' south and which bears S. 10° E., is sealed.

\* G-16-4 A view of the air course, which bears S. 40° E. The adit is open for about 50'. A door partially blocks the opening. The adit should be sealed.

The adit at the Defiance No. 2 Mine and the adit at the Defiance No. 6 Mine should be backfilled. Possibly the coal bed exposed at the dozer trench at the Defiance No. 3 Mine should be covered to prevent its firing.

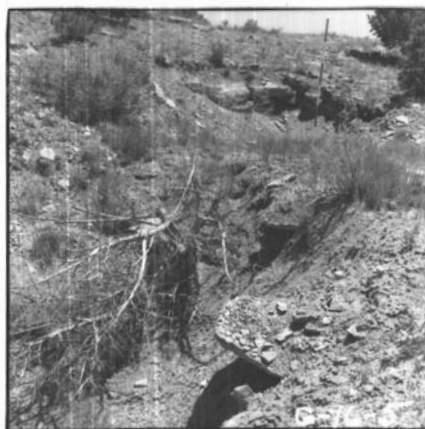
G-16-5 Approximately 300' to the south the main adit, which is sealed, is shown in this photo. The adit bears about S. 10° E.

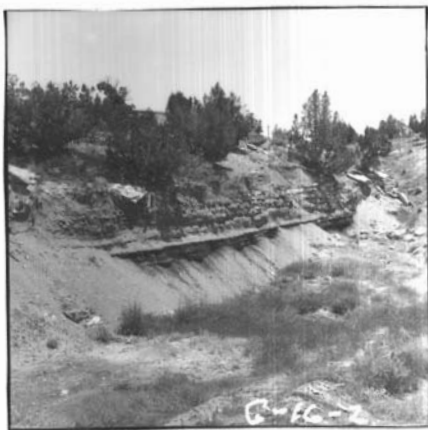
One of the adits bears N. 64° E. and is practically closed except for a varmint-size opening. The other adit was made a part of a bulldozer trench, which bears S. 20° E. The coal bed is exposed in the trench.

G-16-2 This is a view of the dozer trench that was dug through one of the mine openings. Coal is exposed in the trench but the adit is sealed. The photo was taken looking S. 20° E.

Reclamation is not needed. The coal is exposed in the trench, but the lands are leased by Carbon Coal Company, which is an actively mining company and which would put out a fire if it should start.

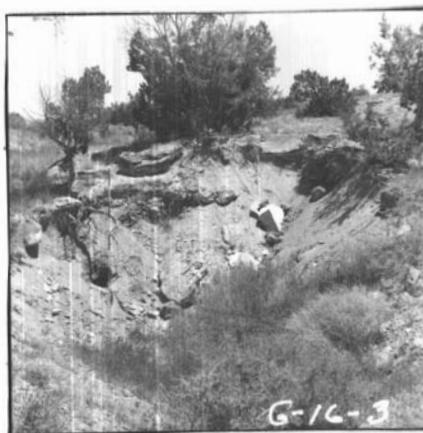
G-16-3 A view of the other adit, which bears N. 64° E. A varmint-size opening is present at the top of the portal.

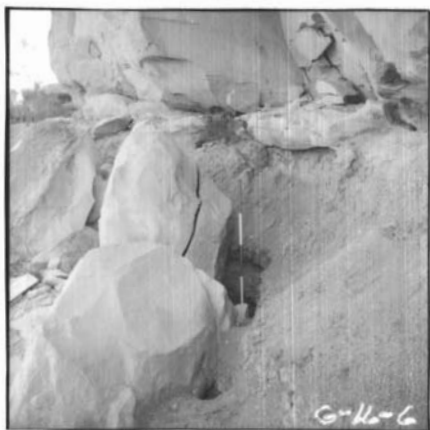
The mine was developed through two adits, both bearing N. 15° E., 50' apart. One adit is partly open.

G-16-6 View of slope bearing N. 15° E. The slope is open at the range pole. The opening is possibly not dangerous in itself, but it probably should be backfilled to avoid any access as there is habitation within 300 yards.

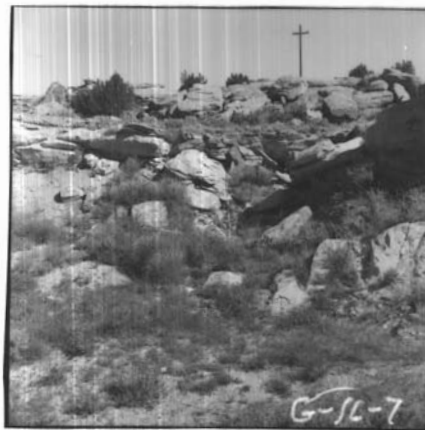
G-16-7 View of the second opening, with the same bearing, 50' left of the opening at G-16-6. The adit is sealed.

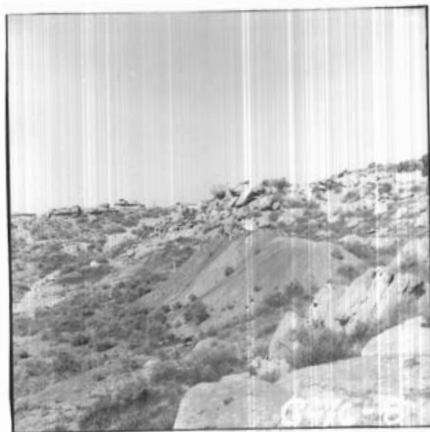
G-16-8 A view of the dumps, looking S. 50° W. Note the foundations on the left. These are the remains of the miners' huts.
