## MEMORANDUM

SUBJECT: Reclamation evaluation for OSM, Gallup Field, Gallup West,  
Mulholland, Casna, Allison, Diamond Mines

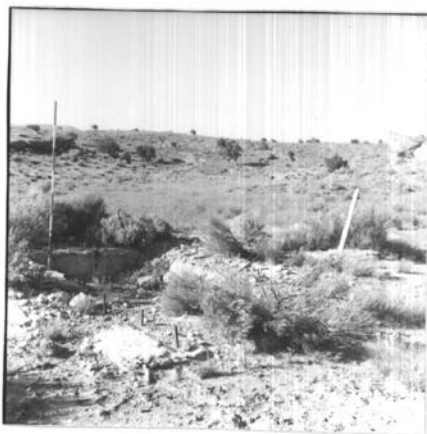
There is a small ventilation and manway shaft, sealed, on top of the knoll beyond the water tank at Location 45. A construction and equipment rental man who owns the land has his shops and equipment storage yard in the old mine yard, and he has done quite a bit of leveling. Consequently, some of the old slopes and openings are filled and their locations can not be determined. Two slopes are shown along the rim south of the shaft at Location 45. These openings are hardly discernible and were not on the map because of the old dump evidence. These dumps represent the early mine workings. A

G-17-8 A view of a ventilation and manway shaft on the knoll west of the water tank. Note the foundation and bolts where the fan and motor were bolted down. The small opening on the right served as a manway.

No reclamation is needed.

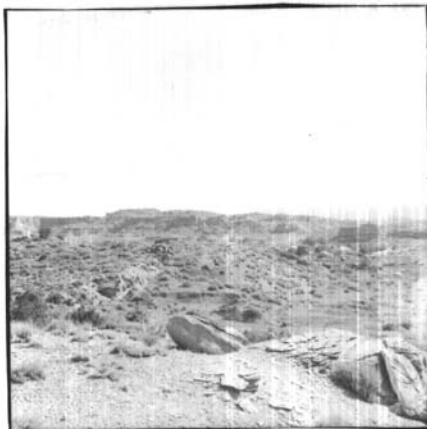
G-17-10 Looking N. 40° E. at the remnants of dump. The town of Allison is in the background.

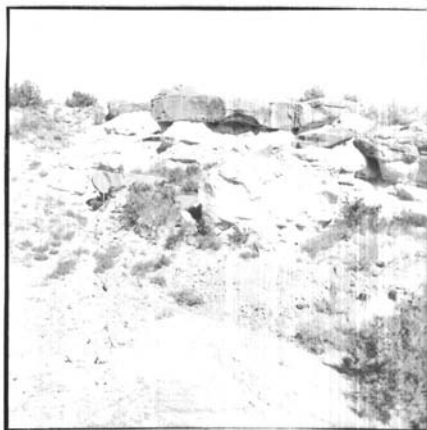
slope, sealed, was found at Location 46. This may have been the slope mentioned in the history that was used to give entrance to men and mules. No openings found need to be backfilled.

G-17-11 View of a sealed slope at Location 46. This opening may have been the manway and animal way described above. It is well sealed.
