## MEMORANDUM

SUBJECT: Reclamation evaluation for OSM, Gallup Field, Gallup East,  
Independent Mine - Carretto Mine

\* Independent Mine - Carretto Mine 5000' NL, 3200' EL, 14-15-18,  
Location 77

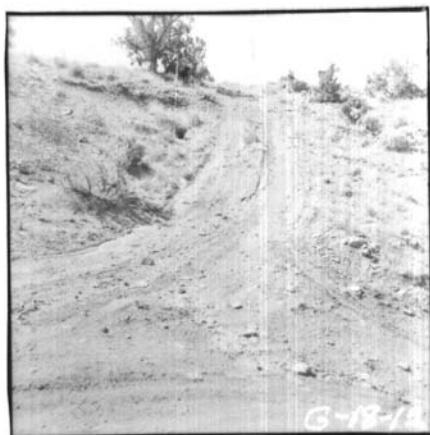
G-18-12 View of a sealed edit on the upper coal bed. The adit bears S. 22° E.

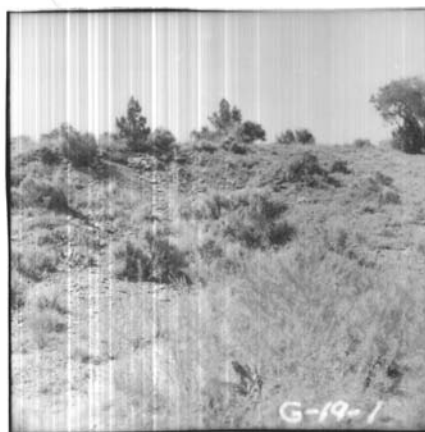
G-19-1 View of the upper adit, which bears S. 32° E. The adit is sealed.

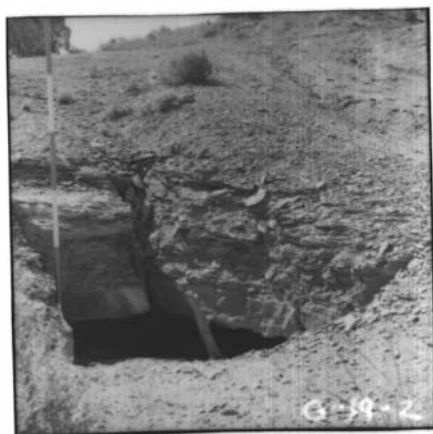
\* G-19-2 View of the small air shaft, which is open about 4' deep. This probably should be backfilled.

The air shaft should probably be filled if reclamation is being done in the area.

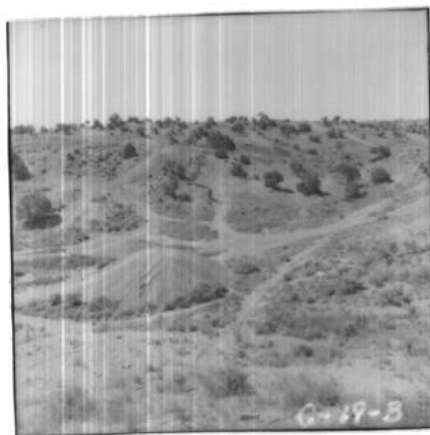
G-19-3 Looking southerly, a view of the lower adit mine dump is in the foreground, and at the extreme right is a dump from the mine at Location 76. The dump in the background is from the upper Carretta mines.
