**MAP SHOWING OUTCROPS OF FAULTS & ACCOMPANYING VEINS**  
in the

**MOGOLLON MINING DISTRICT, CATRON COUNTY, N.M.**

BEARUP MINE

SILVER CREEK MINING Co.

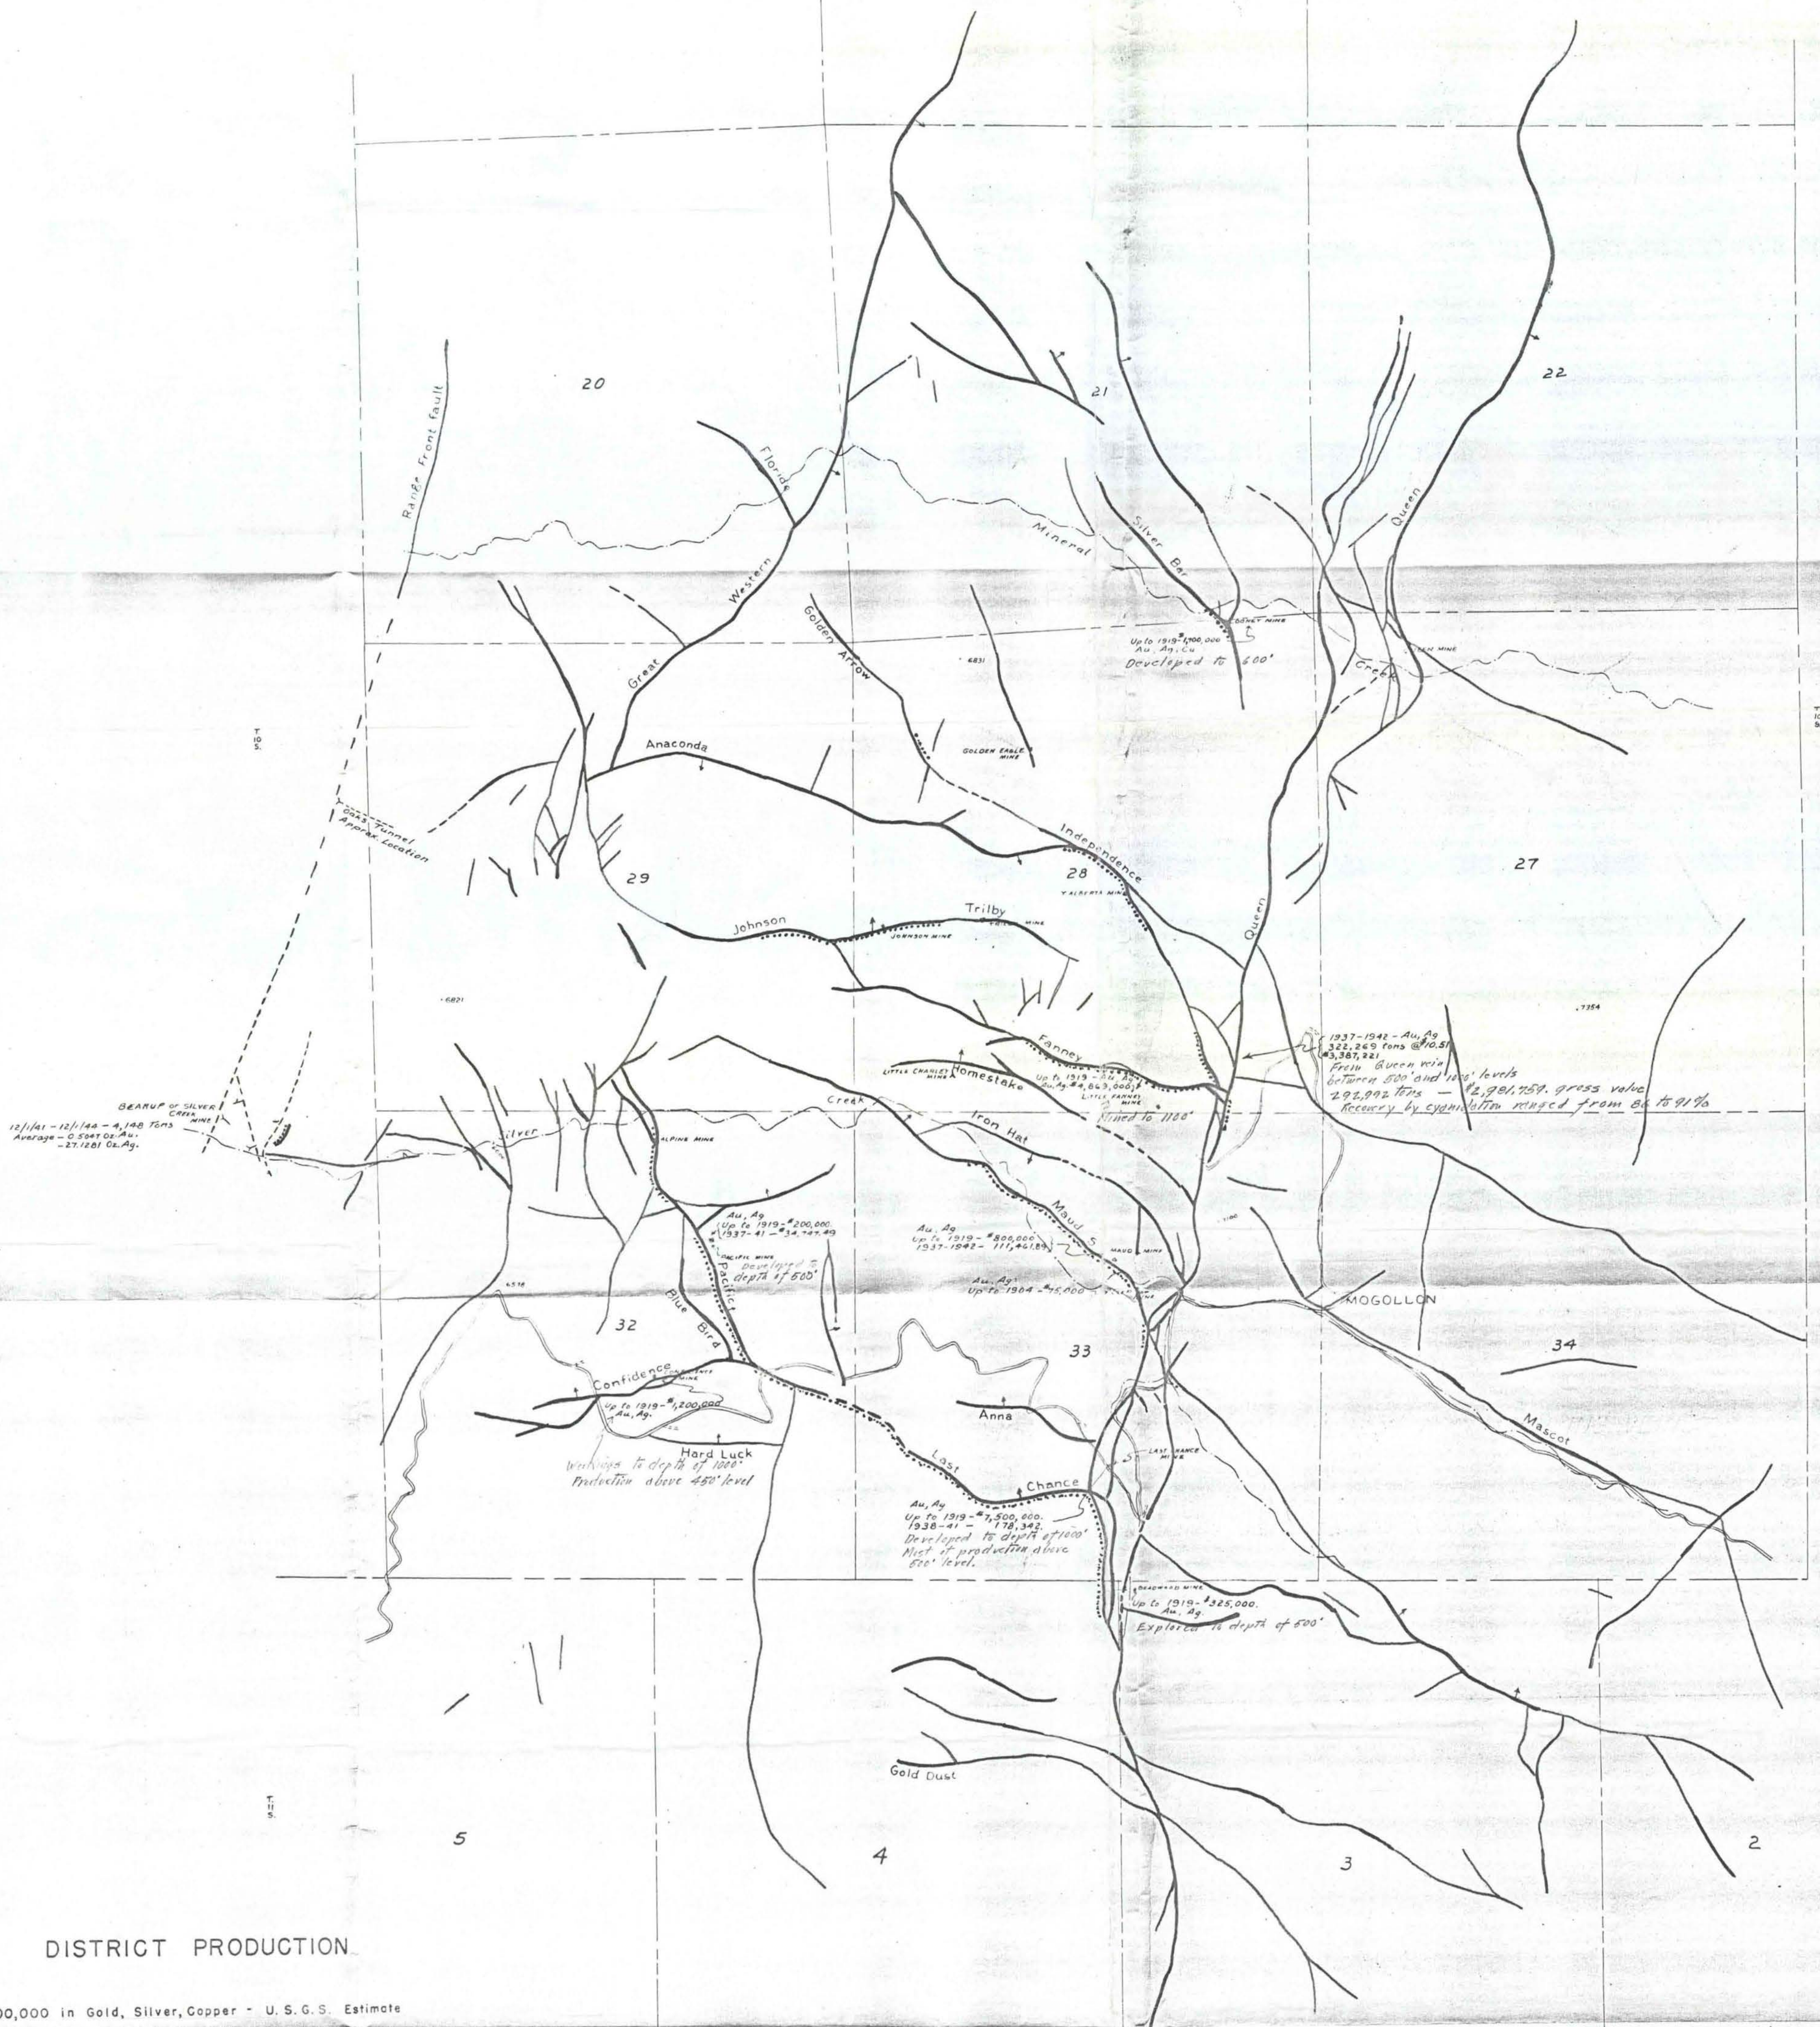
Fault without Vein

Vein

Productive part of vein

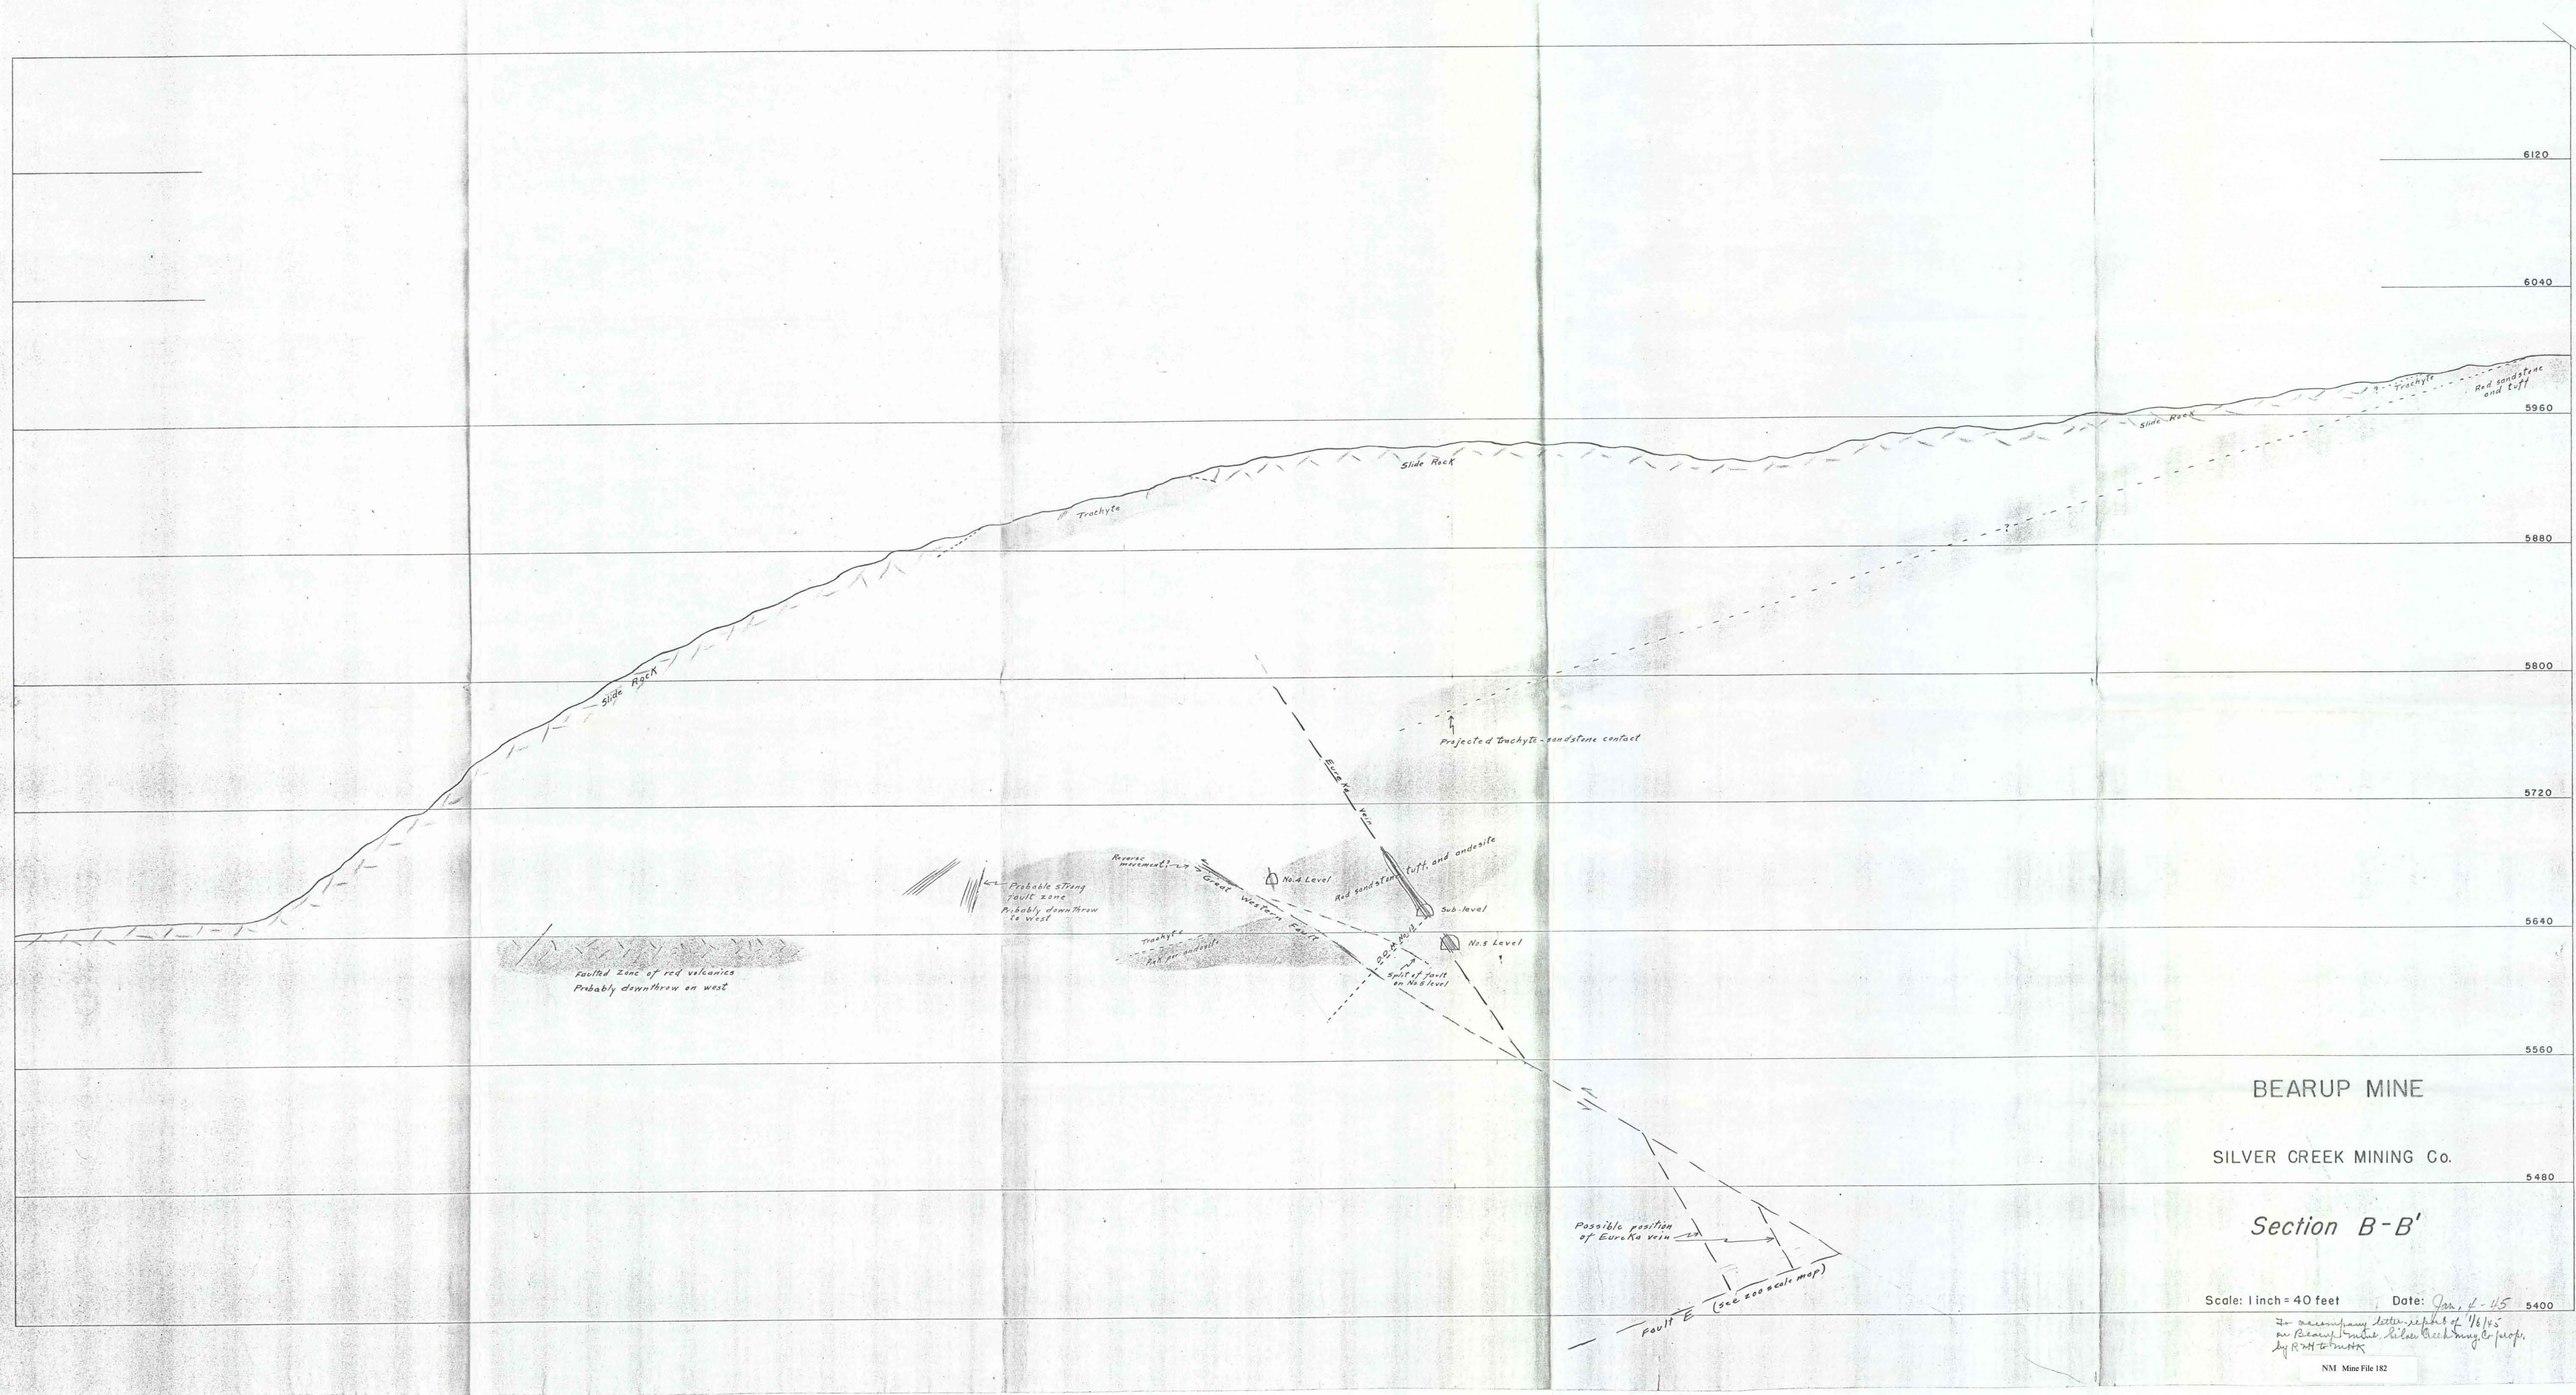
Section B-B'

Scale: 1 inch = 40 feet

For accompanying letter, report of 1/16/15  
on Bearup Mine, Silver Creek Mining Co. property  
by R.H. to D.H.

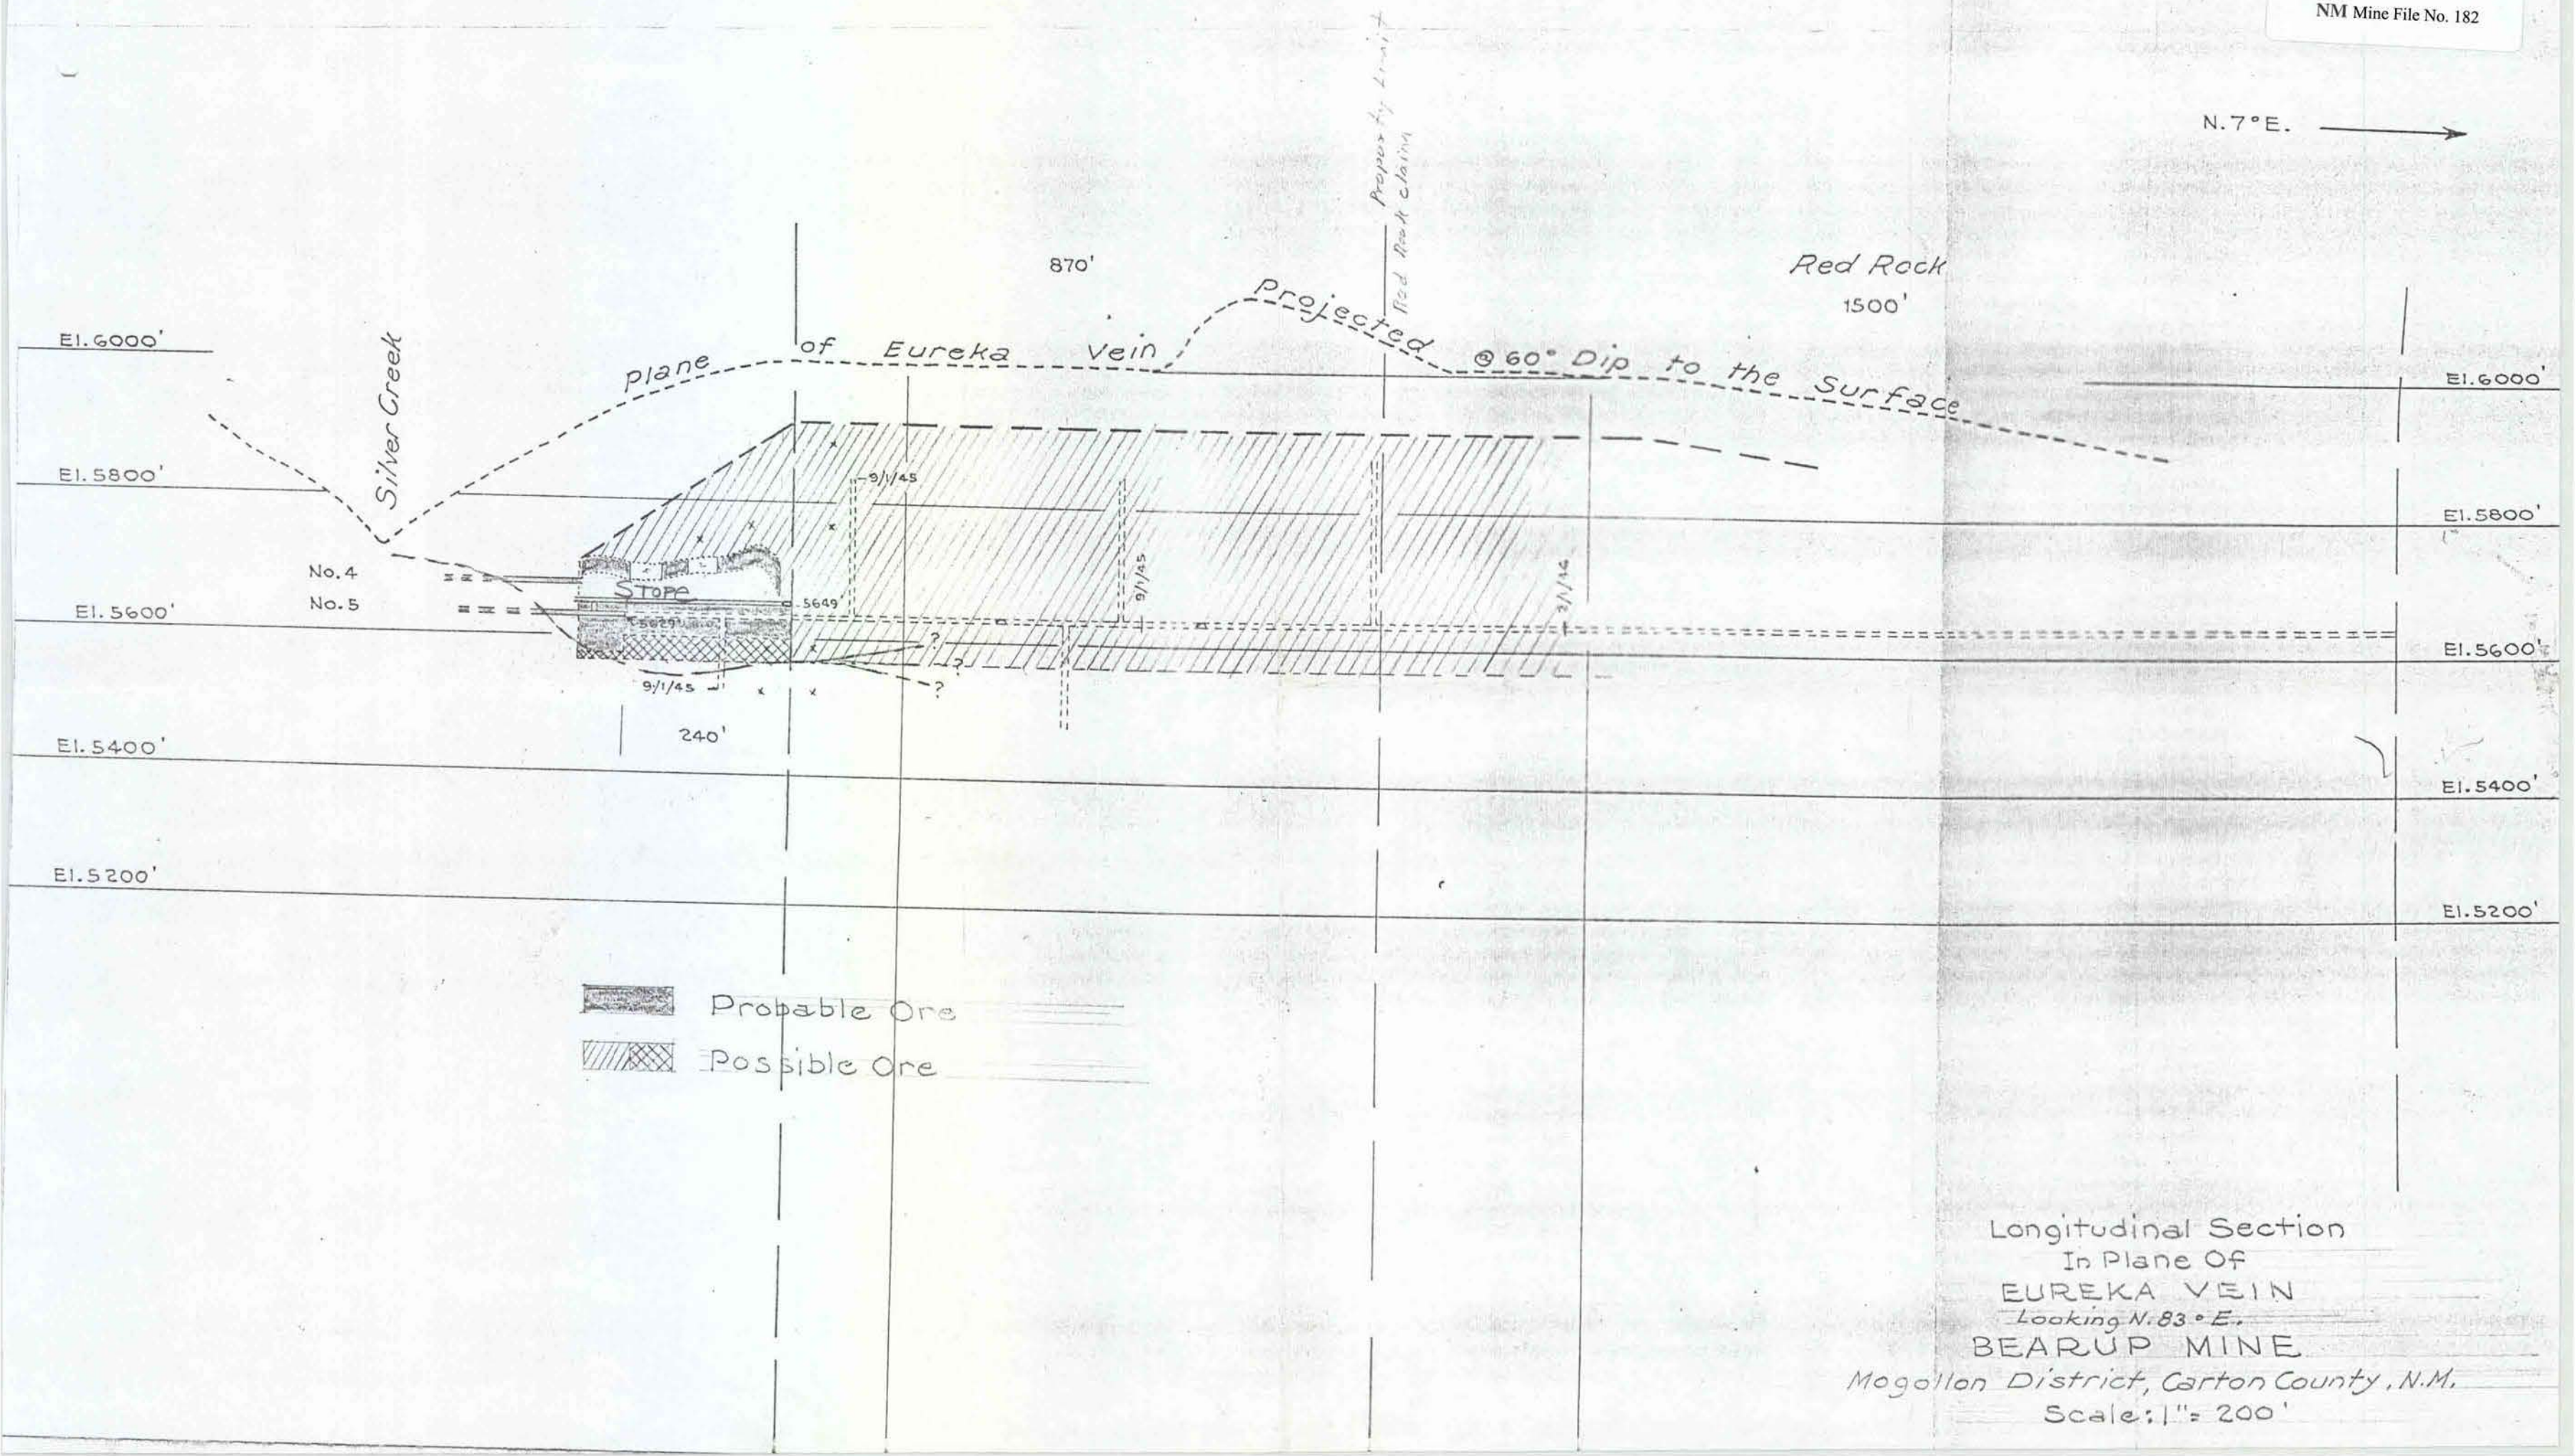
Longitudinal Section  
In Plane Of  
EUREKA VEIN  
Looking N. 83° E.  
BEARUP MINE  
Mogollon District, Carbon County, N.M.  
Scale: 1" = 200'

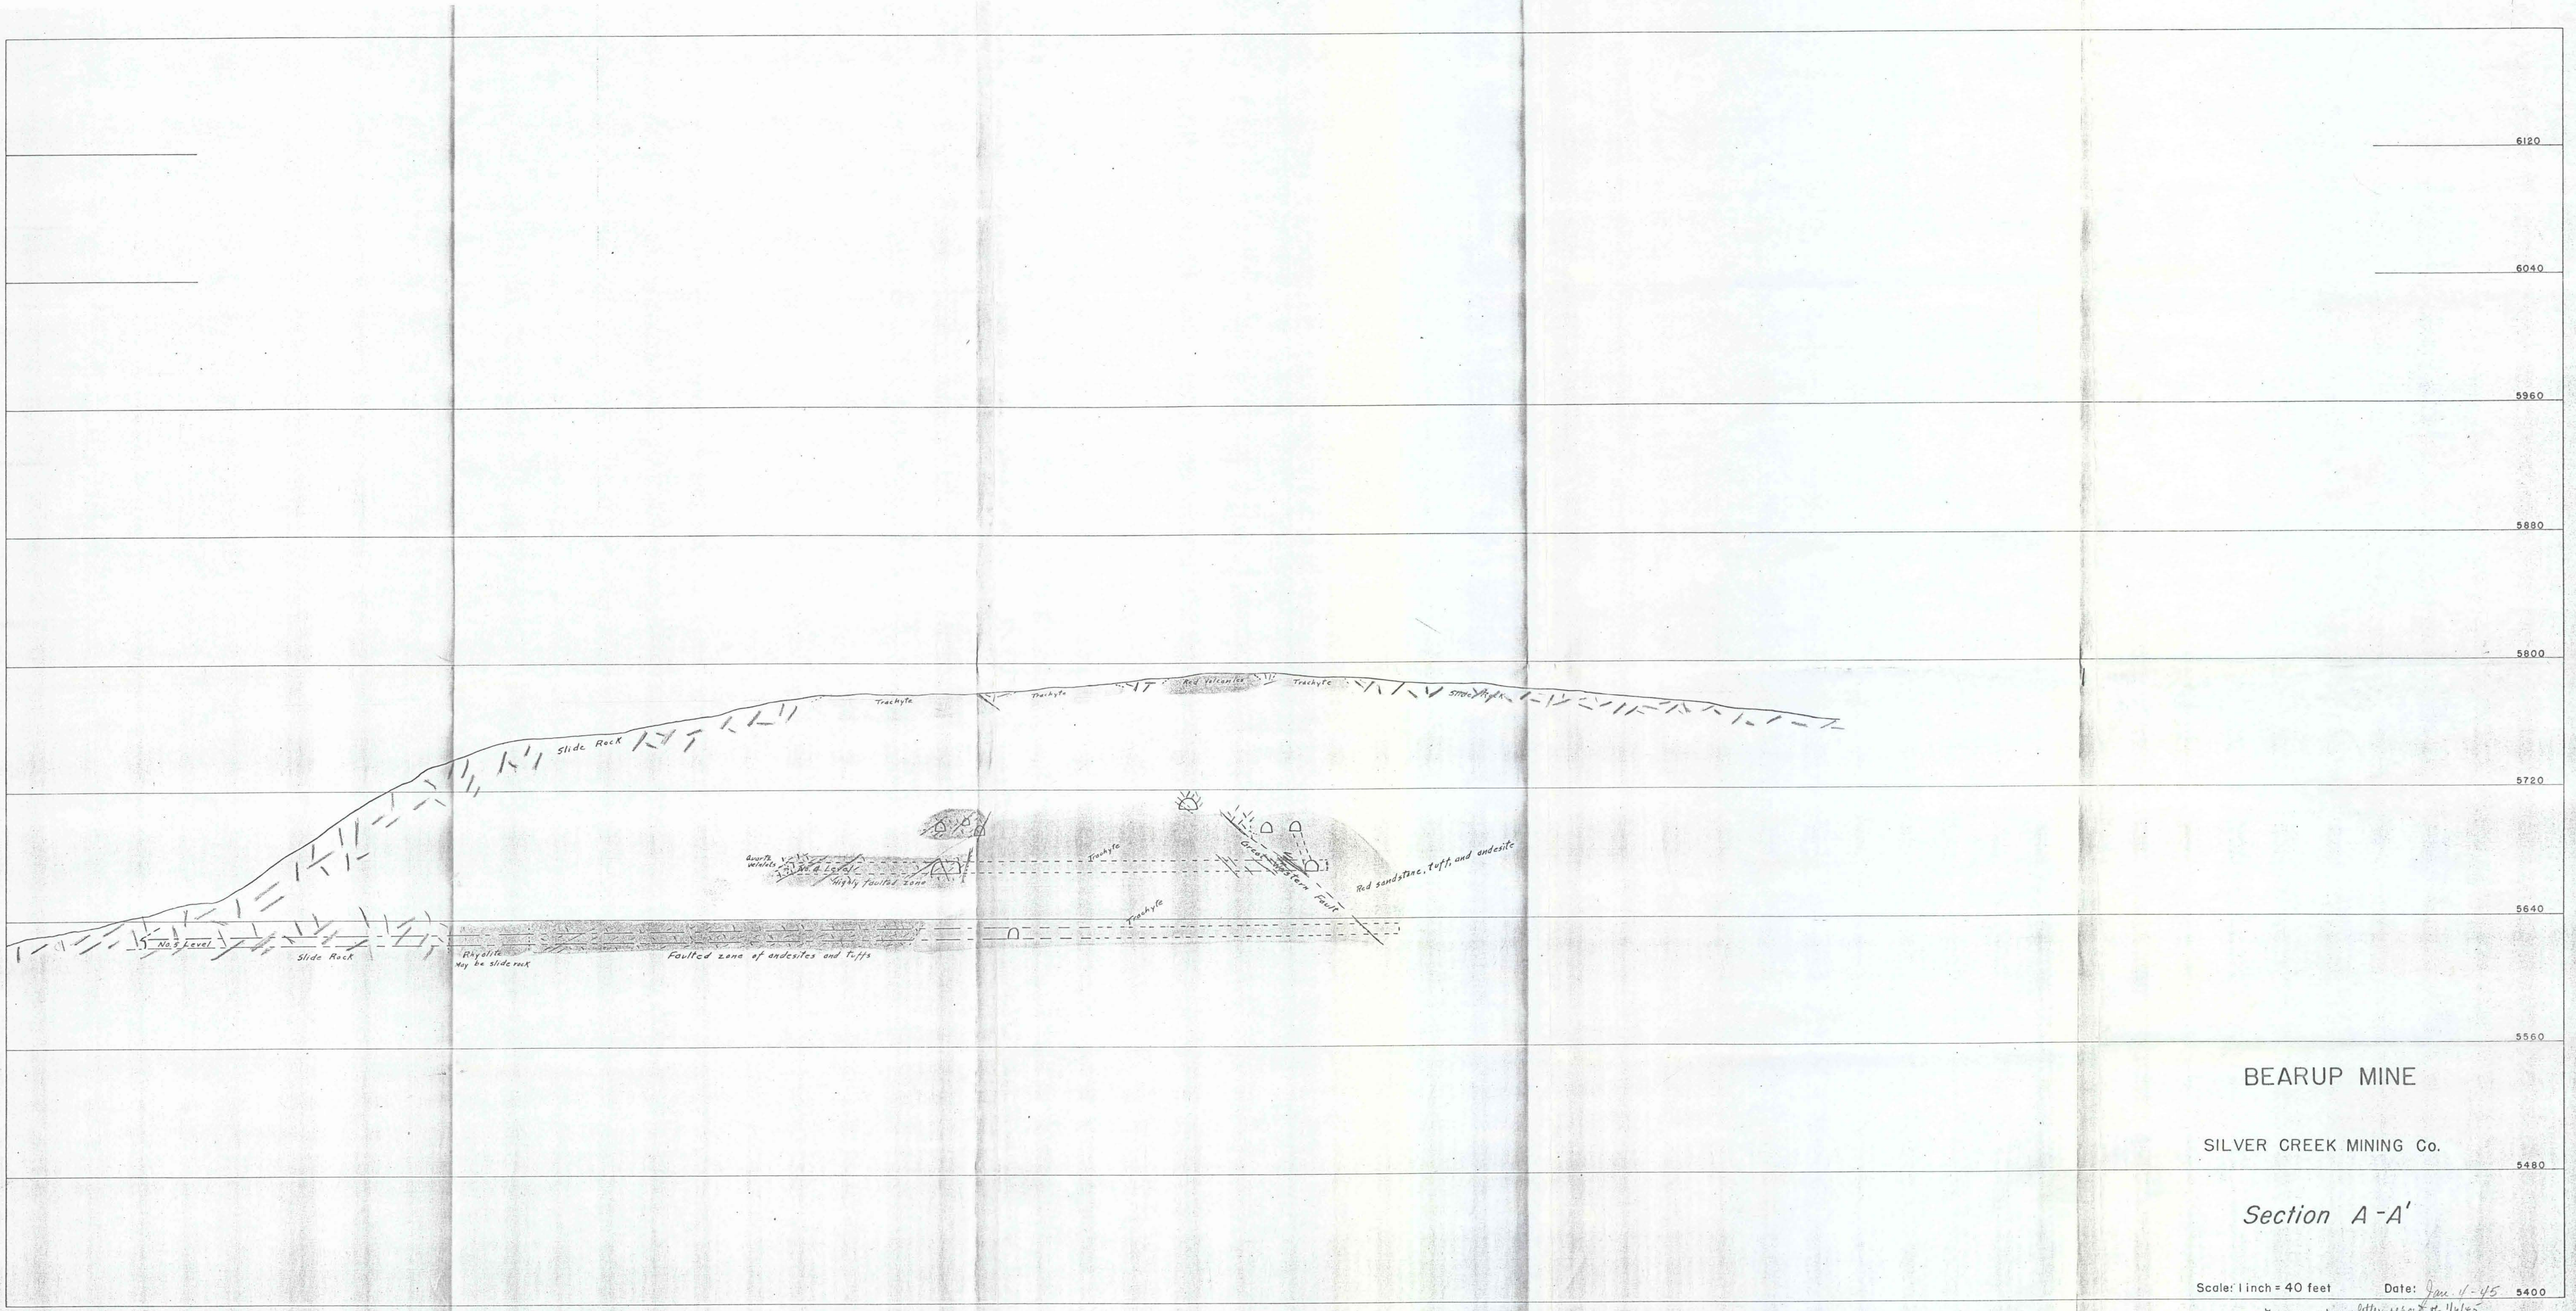
BEARUP MINE  
SILVER CREEK MINING CO.  
CATRON COUNTY, N.M.  
*Surface Geology*  
CONTOUR INTERVAL: 50 FT.

Scale: 1 inch = 200 feet Date: Jan. 17-15

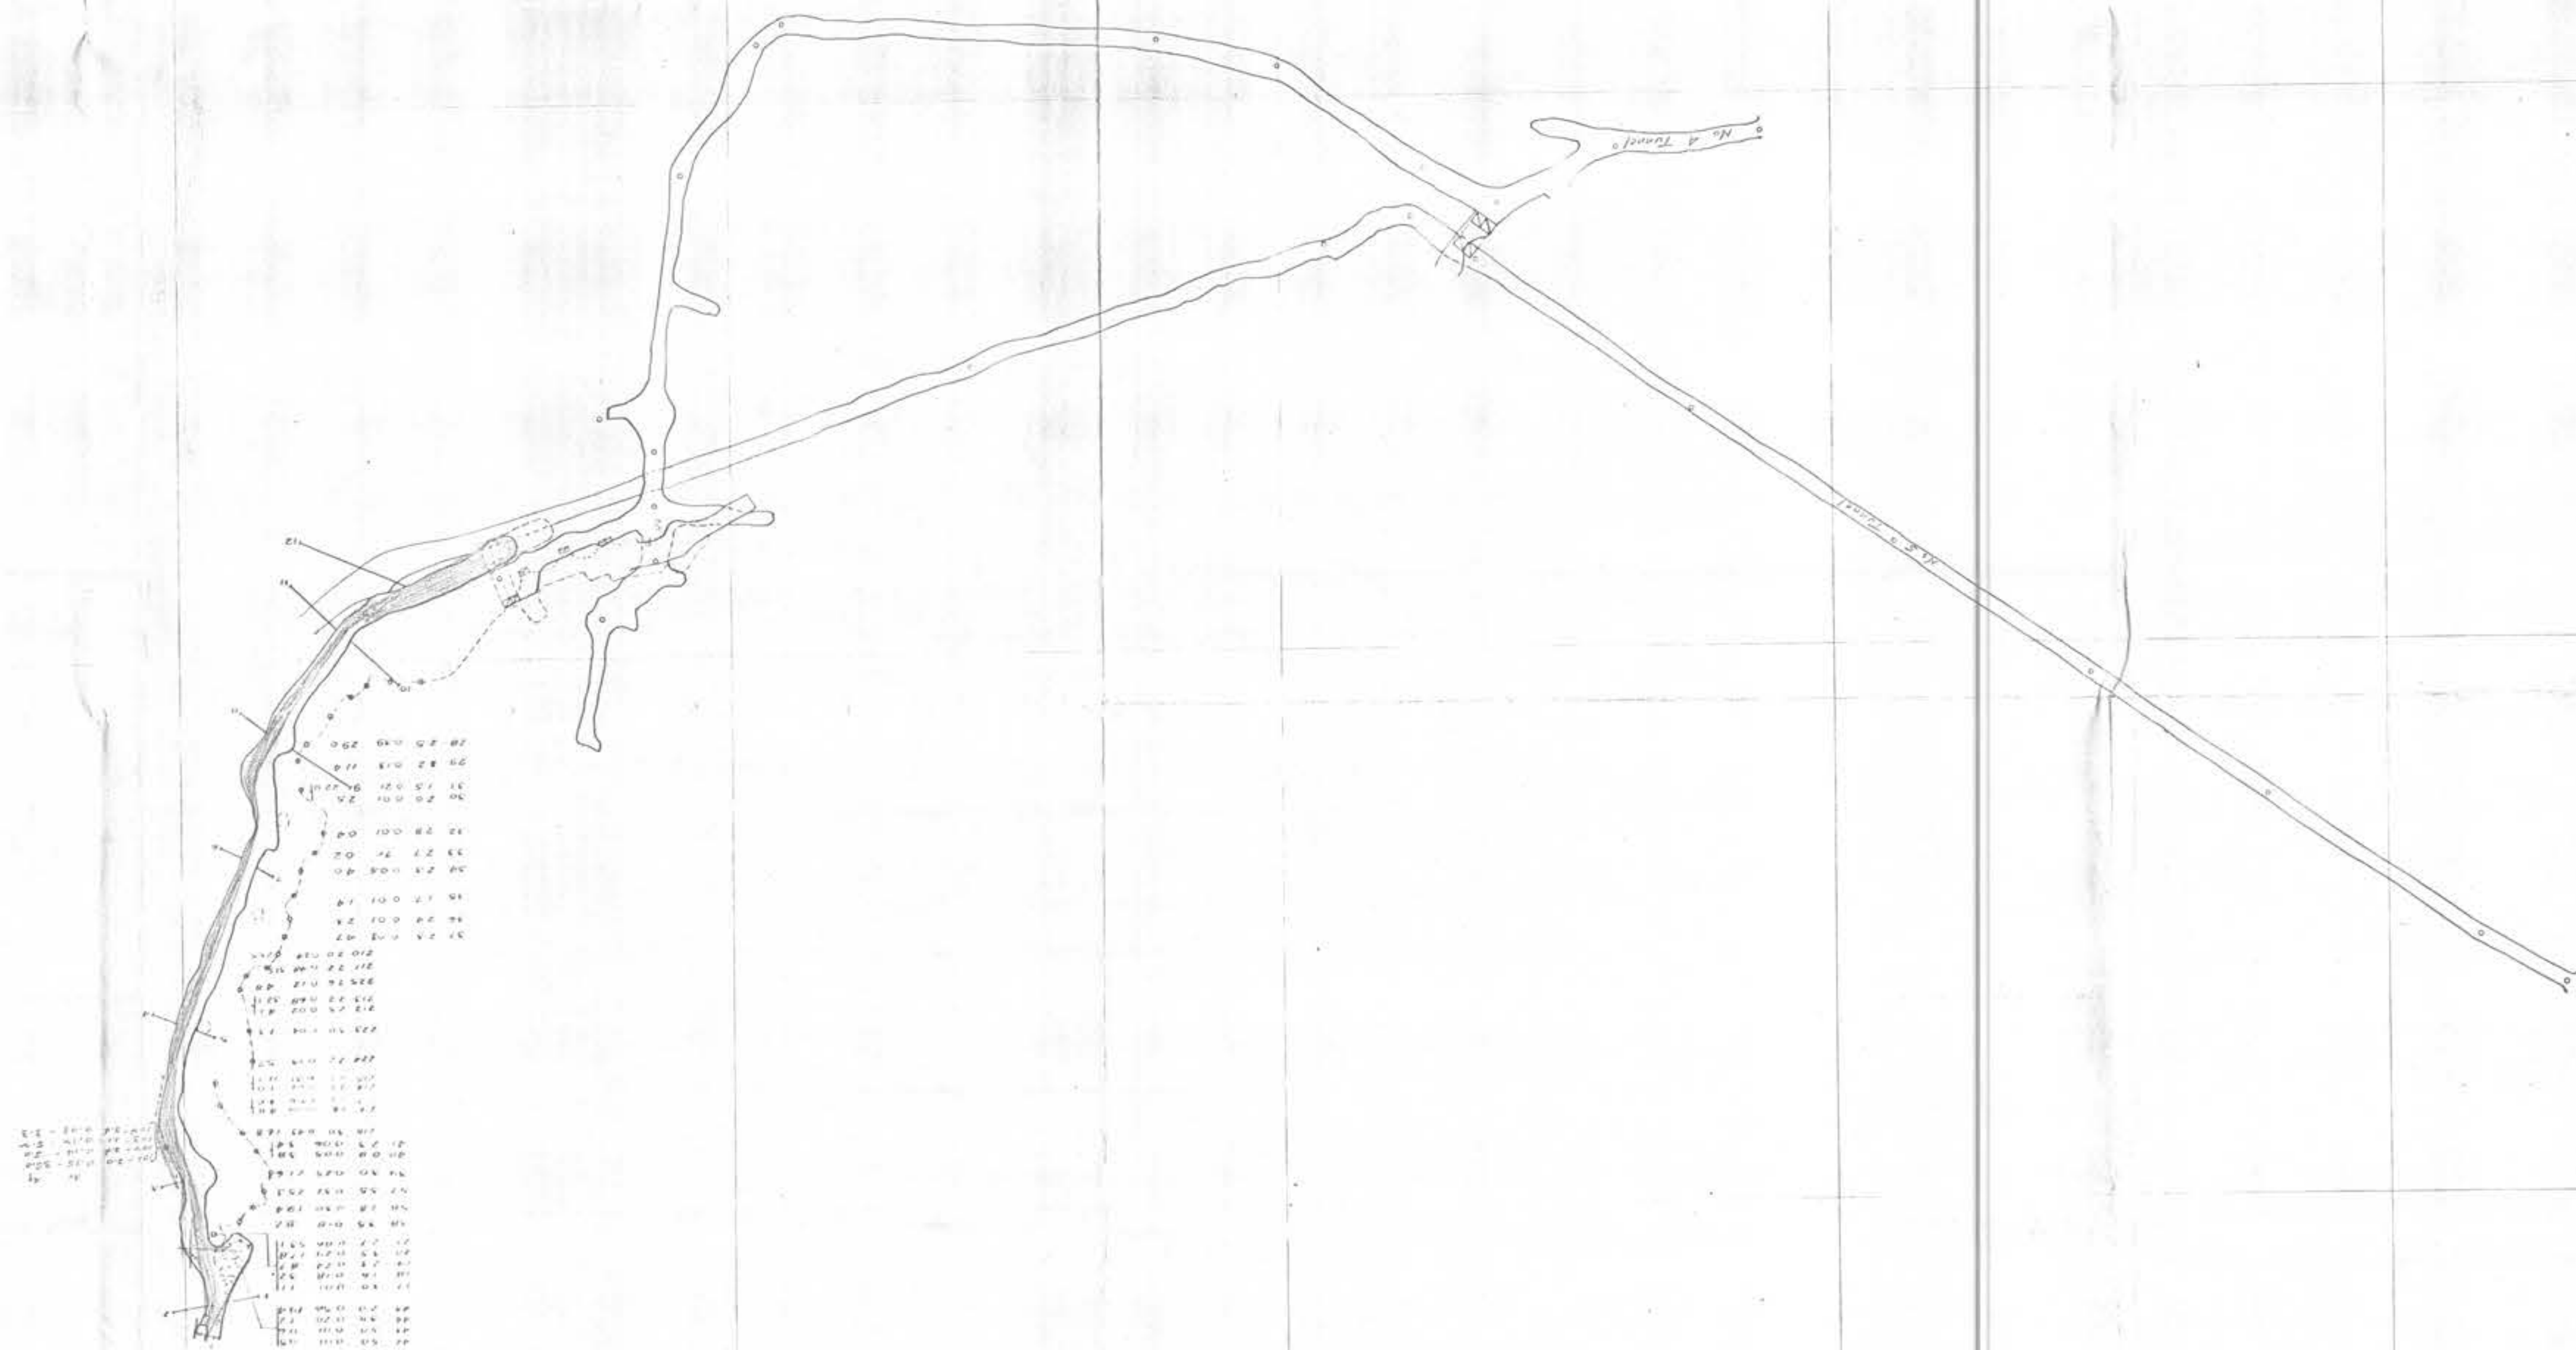
Section A-A'

BEARUP MINE

Scale: 1 inch = 40 feet Date: Jan. 4-45 5400

To accompany letter report of 11/1/45  
on Bearup Mine, Silver Creek Mining Co. property  
by R. H. H. H. H.
